February 2001

Lower Granite Dam

Radial Gate Inspection and Testing

US Army Corps of Engineers, Walla Walla District

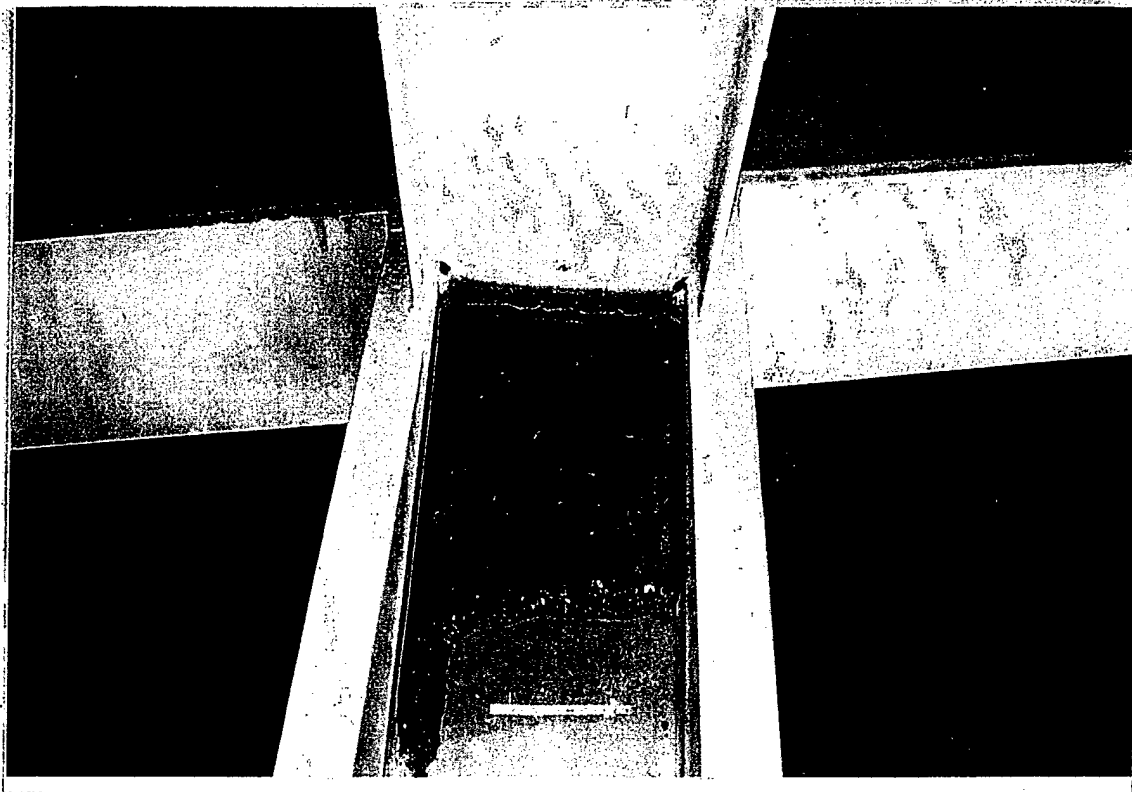
Gate 8
Bottom right corner seal leak.

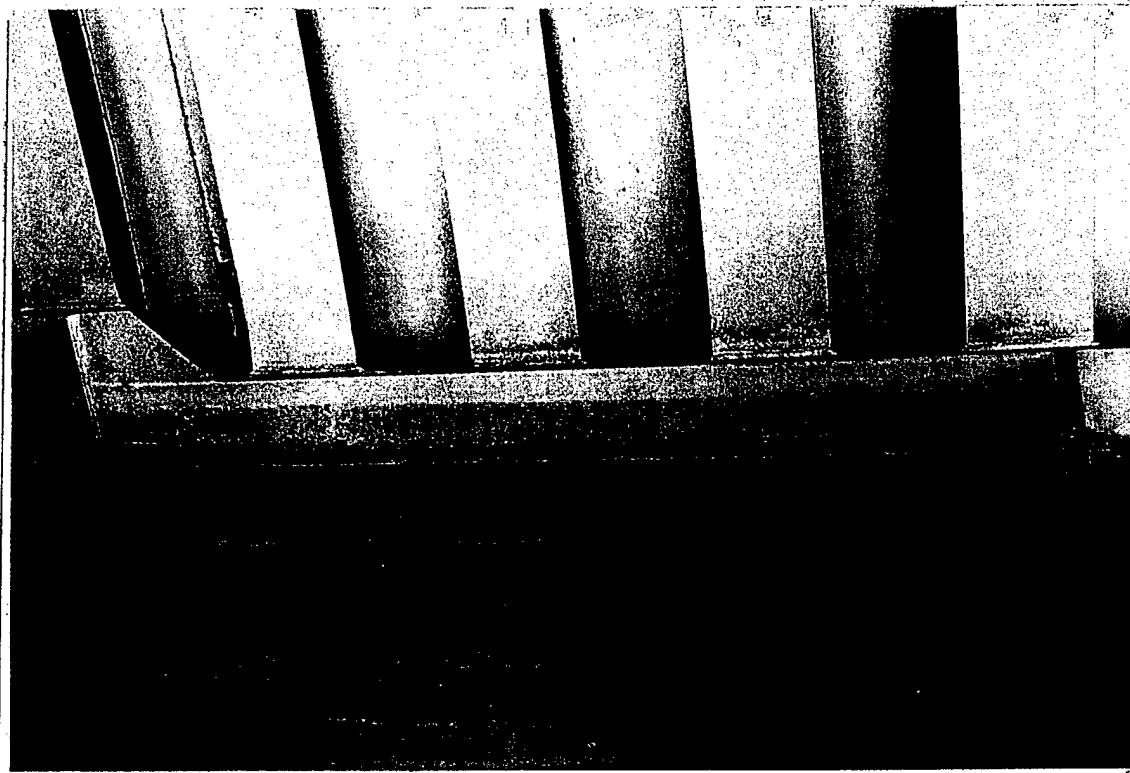
Upstream end of bottom right strut.
Standing water due to inadequate
drainage.

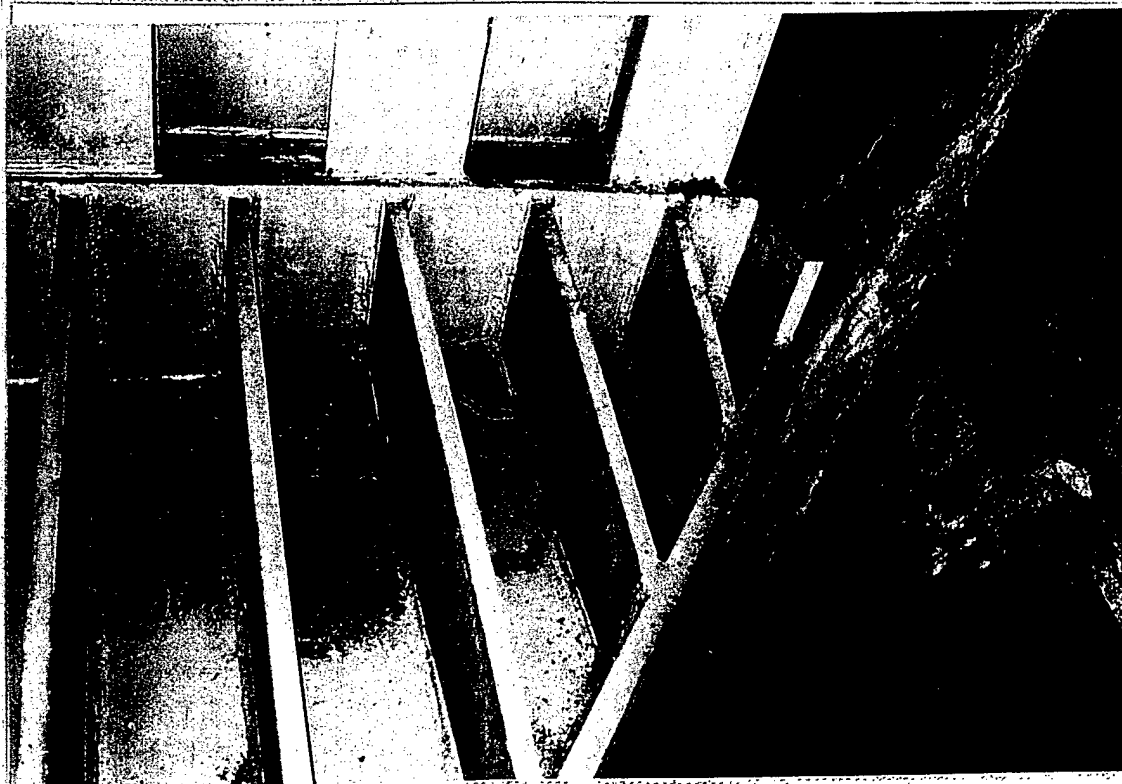
Spillway looking toward left side of
gate. Bottom corner leak.

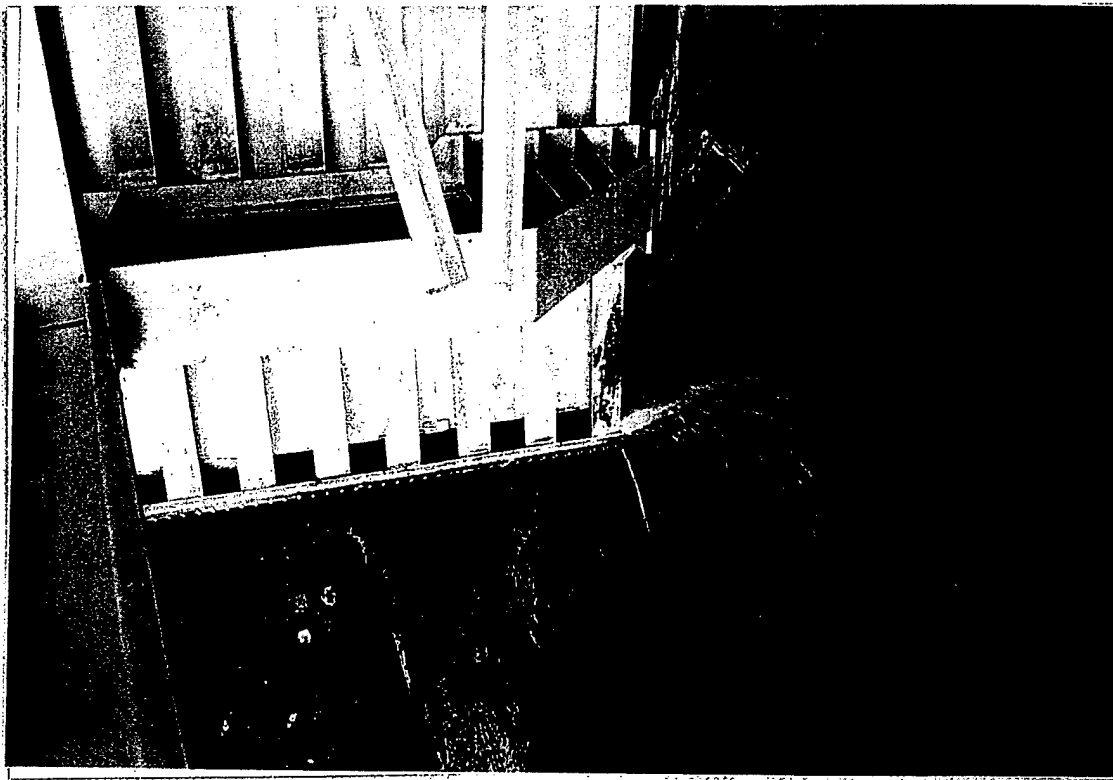
Left end of bottom horiz. girder.
Standing water, no drainage between
multiple stiffeners. Horizontal girder
to skin plate stiffeners, debris and no
drainage.
